STATE OF CALIFORNIA  
DEPARTMENT OF WATER RESOURCES  
DIVISION OF RESOURCES PLANNING

BULLETIN NO. 81

INTRUSION OF SALT WATER  
INTO GROUND WATER BASINS OF  
SOUTHERN ALAMEDA COUNTY

December 1960

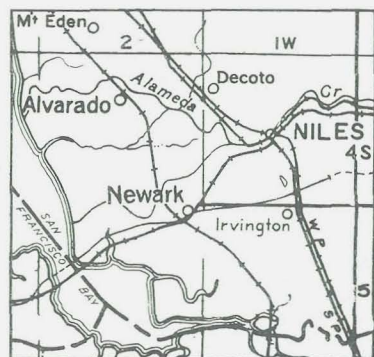
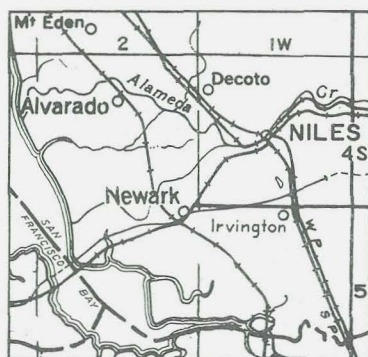
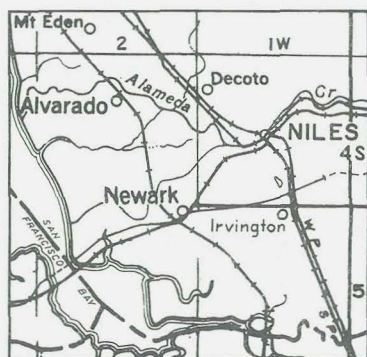
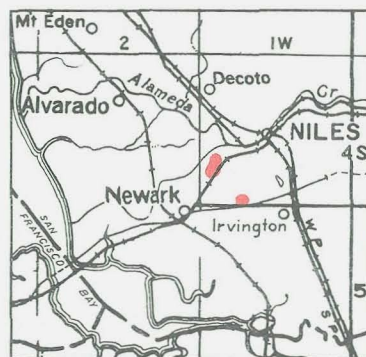
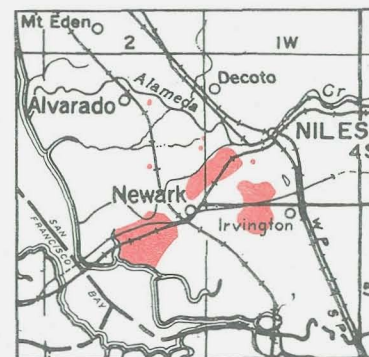
During the six-year period from 1936 to 1942, there was a moderate improvement in the quality of water from shallow wells, probably due to effects of above normal rainfall. In 1950, and again in 1957, however, it was found that bay water had intruded further inland in the Niles cone area. The progressive degradation of waters in the Newark aquifer is illustrated on Figure 1.

DEGRADATION OF SHALLOW (NEWARK AQUIFER) AND DEEP (CENTERVILLE AQUIFER) GROUND WATER

deep wells in the vicinity of Newark and Alvarado were reported to be yielding salt water. By the end of 1950, about 100 acres of the Centerville aquifer produced water with chloride concentrations in excess of 350 ppm; this area of degraded water increased to about 230 acres early in 1951.

By late 1958, about 2,630 acres of the Centerville aquifer were affected (Plate 6). Samples collected during 1959 show that about 3,000 acres were degraded by salt water.

The foregoing observations, summarized on Figure 1, clearly show a progressive increase in the area of degraded water in the Centerville aquifer.

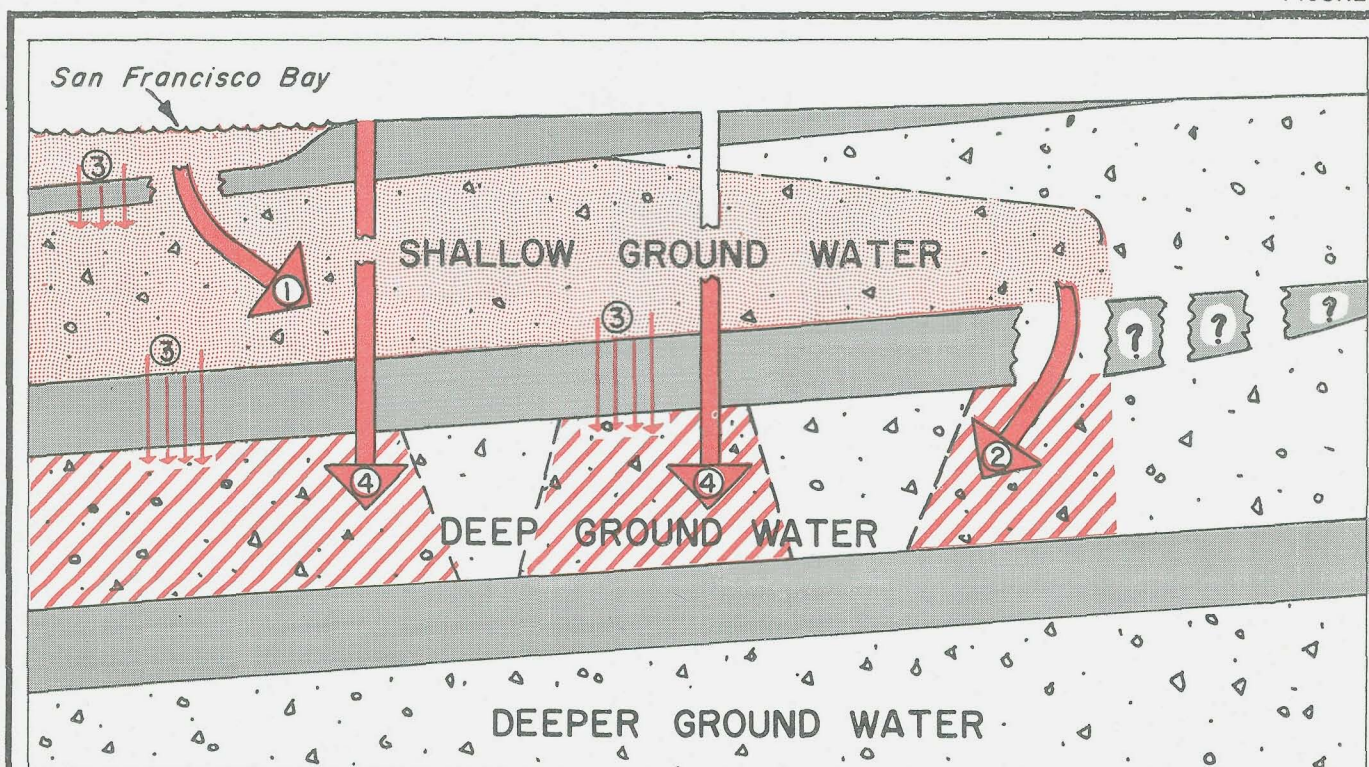
FIGURE 2

Possible means for entry of salt water into ground waters are delineated on Figure 2. It is seen that there are three natural routes for subsurface movement of salt water into ground-water reservoirs. The one man-made route permits leaking or cascading of saline surface or ground water through wells. The shallow ground-water reservoir corresponds to the Newark aquifer and the deeper reservoirs correspond to the Centerville and Fremont aquifers.

1. Direct movement of bay waters through natural "windows".
2. Spilling of degraded ground waters.
3. Slow percolation of salt water through reservoir roof.
4. Spilling or cascading of saline surface waters or degraded ground water through wells.
